Part 2

The MLGW Way...Forward

Memphis, TN
October 21, 2019

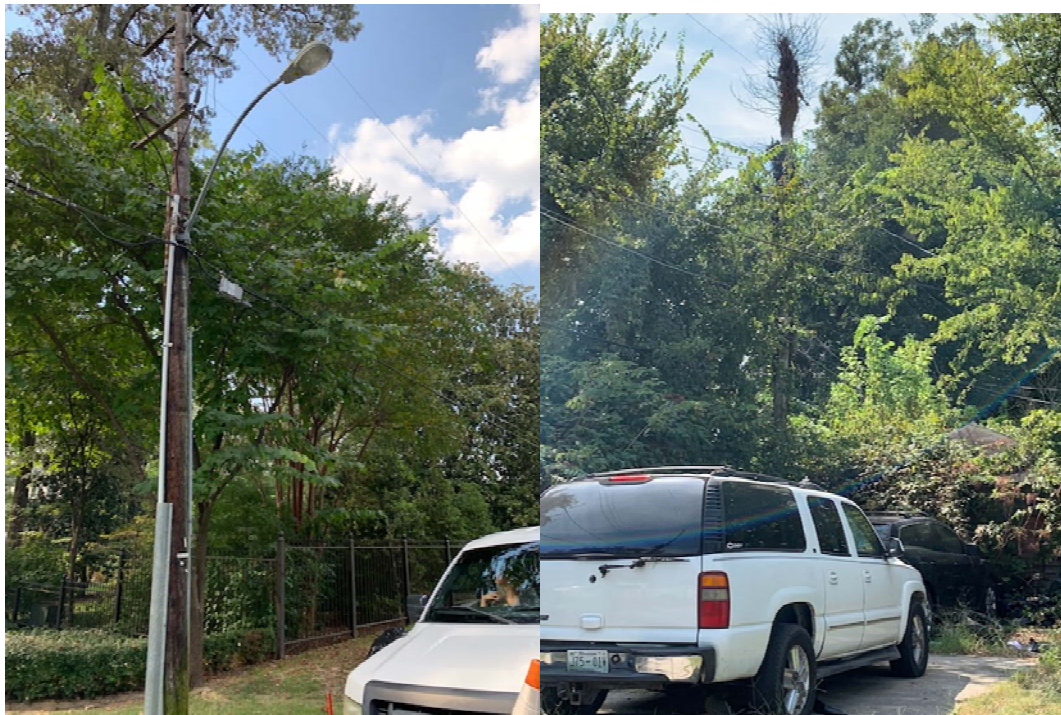
Figure 3-1. Growth cycle since last trim

3.2.1.1 Vegetation management – as an industry standard vegetation management is best completed via cycle trimming. MLGW reliability numbers indicate trees are the number one cause of outages on the system. With cycle trimming the type of vegetation drives the cycle schedule. In the Memphis area the hot humid climate accelerates vegetation growth.

The vegetation cycles are generally completed within a five year cycle; however the MLGW service territory vegetation requires a more frequent cycle trimming. Specifically Kudzu is problematic for electric lines with evidence of electric line conflicts throughout the MLGW service area.

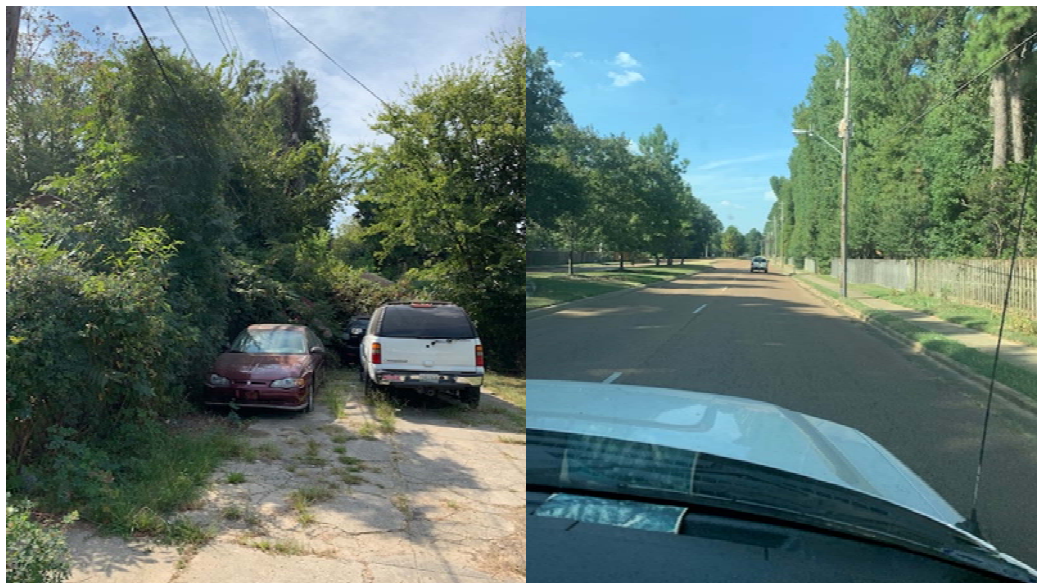
Figure 3-3. Back lot and street view of vegetation management

The transmission corridors are in good condition from a vegetation management perspective. On the distribution system, corridors along streets and road are in much better condition than overhead power lines with back lot systems.

Vegetation next to the road can be accessed with machinery making it much more efficient to control vegetation. Back lot infrastructure is difficult to access due to fences and buildings and notification of landowners, therefore requiring manual labor to complete the cycle trim. In Figure 3-3 a comparison of the back lot (left photo) and street view (right photo) illustrates the differences in accessibility.

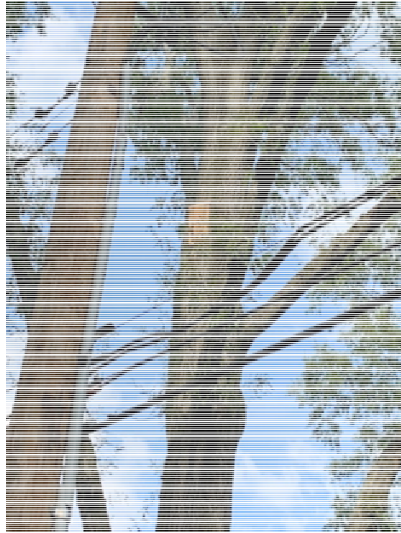
Figure 3-4. Tree canopy

Pride of ownership is different among neighborhoods. In areas where vegetation in back lots are maintained, the Kudzu is kept at bay; however large trees create a canopy over the distribution line causing significant damage if a limb from the canopy falls into the power line. Figure 3-4 shows a recent break of a large limb that came down on the power line below, creating a pole replacement.

The attached riser still has damage which was probably not replaced during the emergency pole replacement due to lack of time.

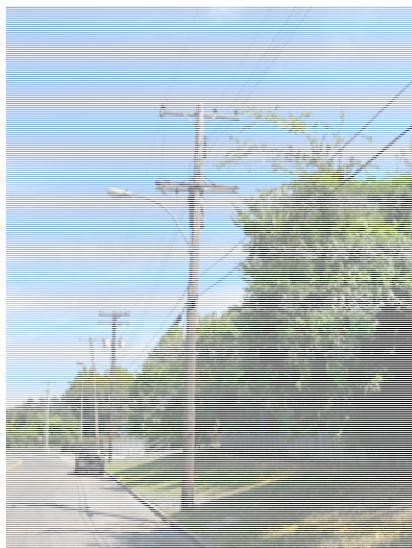
Figure 3-5. Open wire secondary

3.2.1.2 The distribution system has a significant amount of open wire and insulated banked secondary feeding residential load. Utilities have programs to replace open wire secondary. Although the new standard for installing services and overhead secondary is bundled aerial conductor, MLGW appears to have an excessive amount of open wire or banked secondary. Because the secondary is lower than the primary, vegetation will grow into the secondary causing an outage as shown in Figure 3-5. Vegetation is likely to be reported as the cause of the outage by a trouble man. If the open wire secondary were replaced with insulated bundled service wire, the conductor can withstand incidental contact with vegetation without causing an outage. There are also issues with wind causing conductors to contact each other, causing an outage.

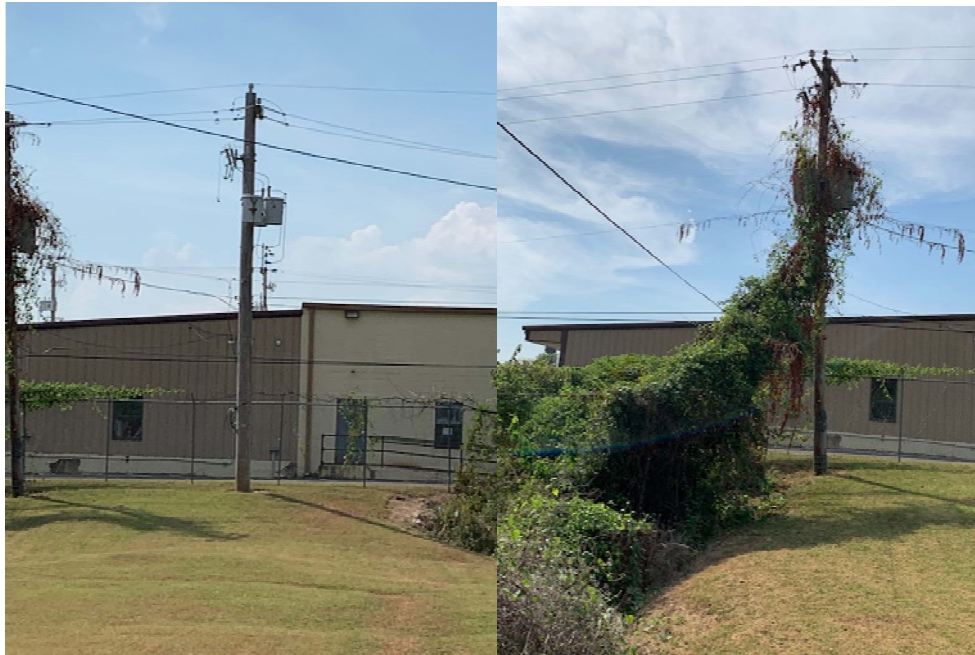
Figure 3-6. Examples of unused transformers

Error! Reference source not found. is an example of an unused transformer with jumpers hanging

loose and fuse doors open. There is also an example of an unused transformer and unused service. The Kudzu has completely engulfed the transformer and is weighting the service conductor, putting extra stress on the transformer pole. Vegetation would normally cause an outage but the service is not energized and an outage is not reported.

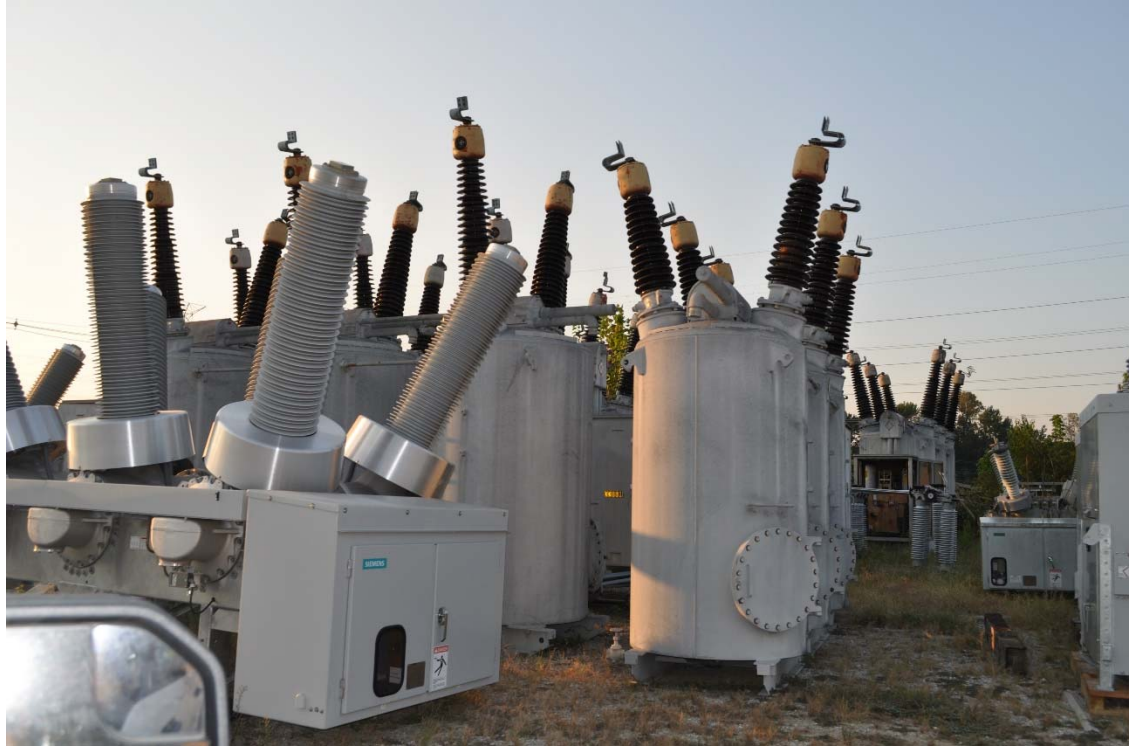
MLGW has also implemented a Substation Asset Group that reviews every maintenance report and decides if action is required to replace an asset or if it is able to remain in service. Overall, the substations are aging but they are maintained adequately and have useful life remaining. Breakers are available for replacement of failed breakers (when visiting Substation #33, several OCB, GCB and vacuum-type circuit breakers were observed within the substation fence inside the yard). However, if a breaker does fail, the requirement is to replace the foundation to meet seismic requirements which would take additional time. Wayne Ellis did mention that the plan is to get the breakers inside a building or warehouse so that they can be sheltered from the elements to prevent moisture and condensation inside the breaker control boxes.

Figure 3-7. Spare breakers sitting inside the substation fence at Station #33

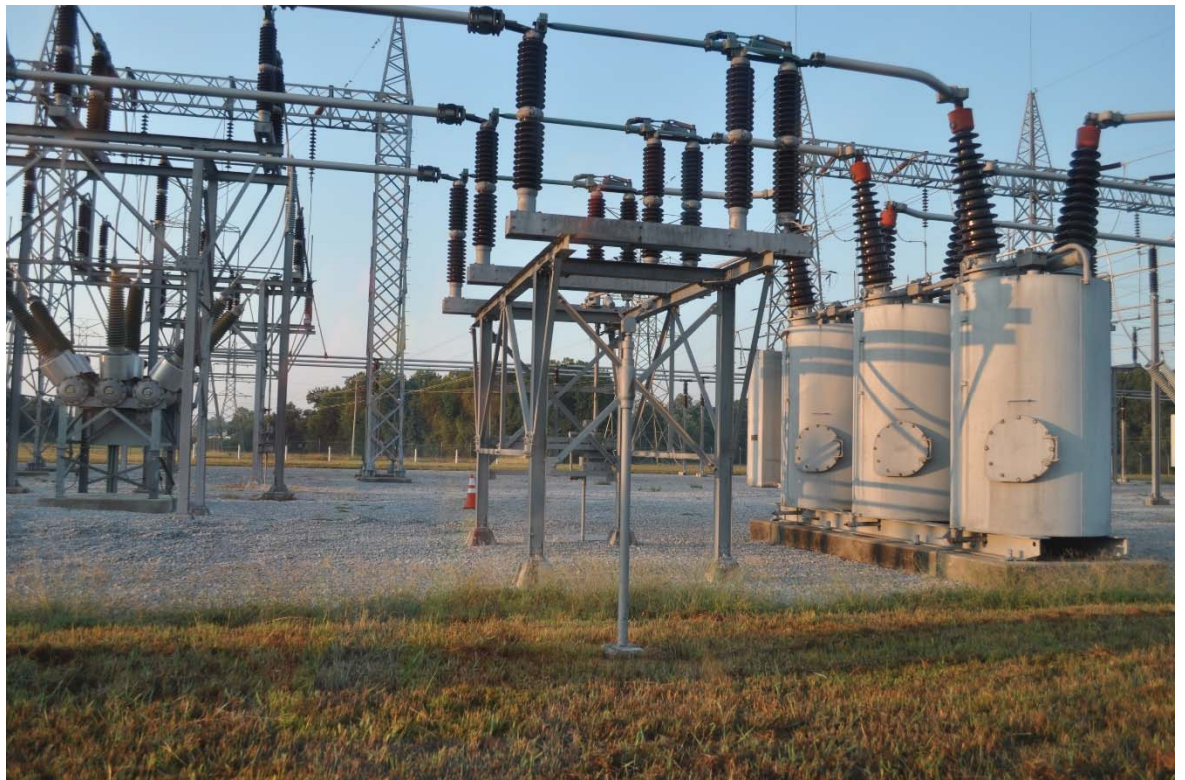
Figure 3-8. Main Bus Tie breaker at Station #33.

Substation #33 is a 161/115kV substation. Both 161kV and 115kV are in a main-and-transfer bus scheme. Right now, there is a tie OCB on the main bus. For a breaker failure of the tie OCB, it would cause a large disruption until the circuits could be switched over to the transfer bus. To avoid such a large disruption, it might be advantageous to consider a series breaker where two breakers are used in series in place of the tie breaker. If there is a breaker failure of one of the series breakers, it will only trip the other series breaker and not the entire adjacent bus and transformer.

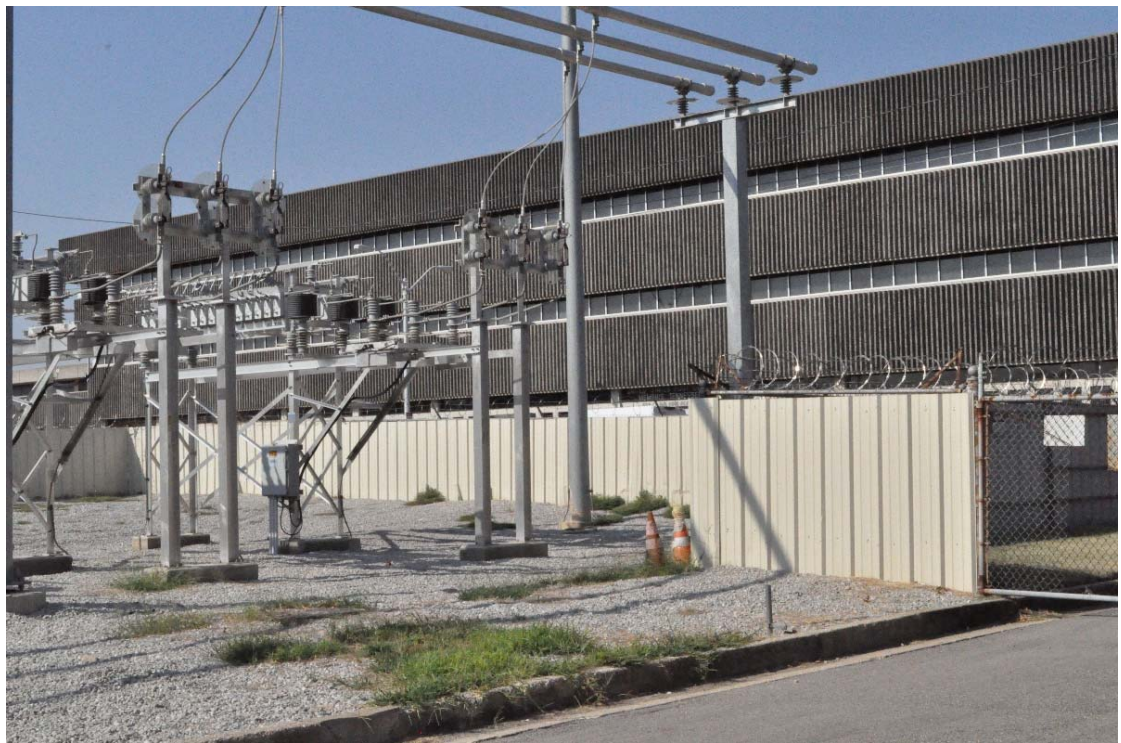
Substation vegetation is also a general concern noted at all sites visited. Weeds and vegetation inside the substation fence were common. A programmatic approach is recommended for weed-spraying inside substations.

Figure 3-9. Substation #3 – vegetation

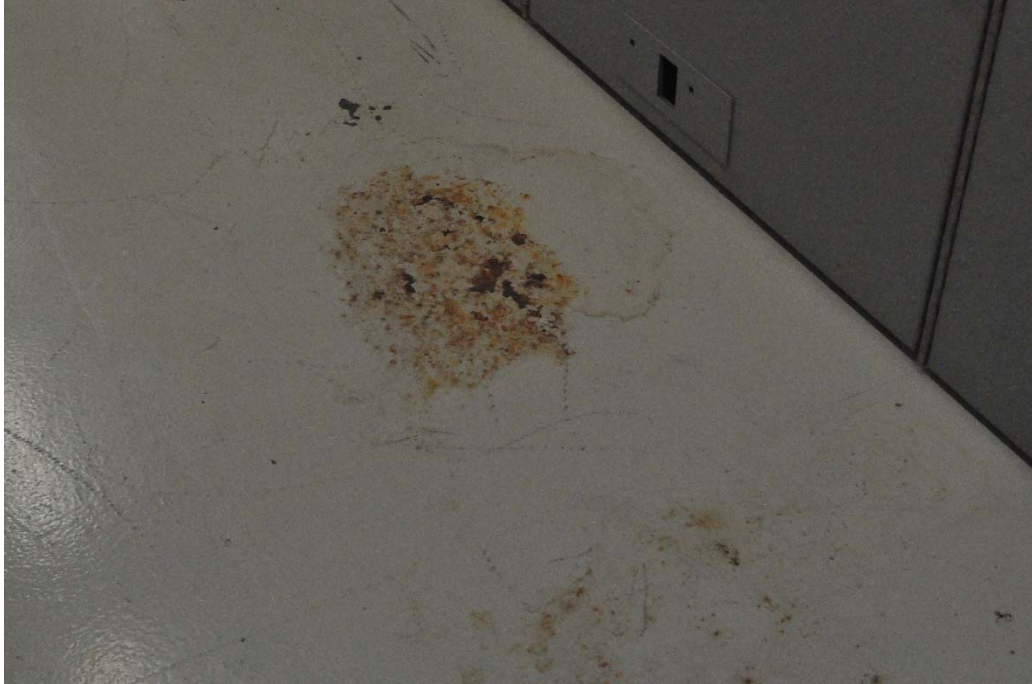
Substation #76 is a 115kV Substation on the high voltage side but all clearances were built out for 161kV which is indicative of proper planning and recognizing that the high side voltage could be increased in the future. The Substation is not heavily loaded right now – at the site visit it was noticed that both transformers were loaded to 16 MVA each while the lowest rating for each is 25 MVA so the substation has room for load growth as well. The switchgear in Substation #76 did have some rust on the floor due to a previous water leak which seems to be an issue with the switchgear buildings that have been previously purchased.

Figure 3-10. Substation #76 – Rust from water incursion inside the switchgear building

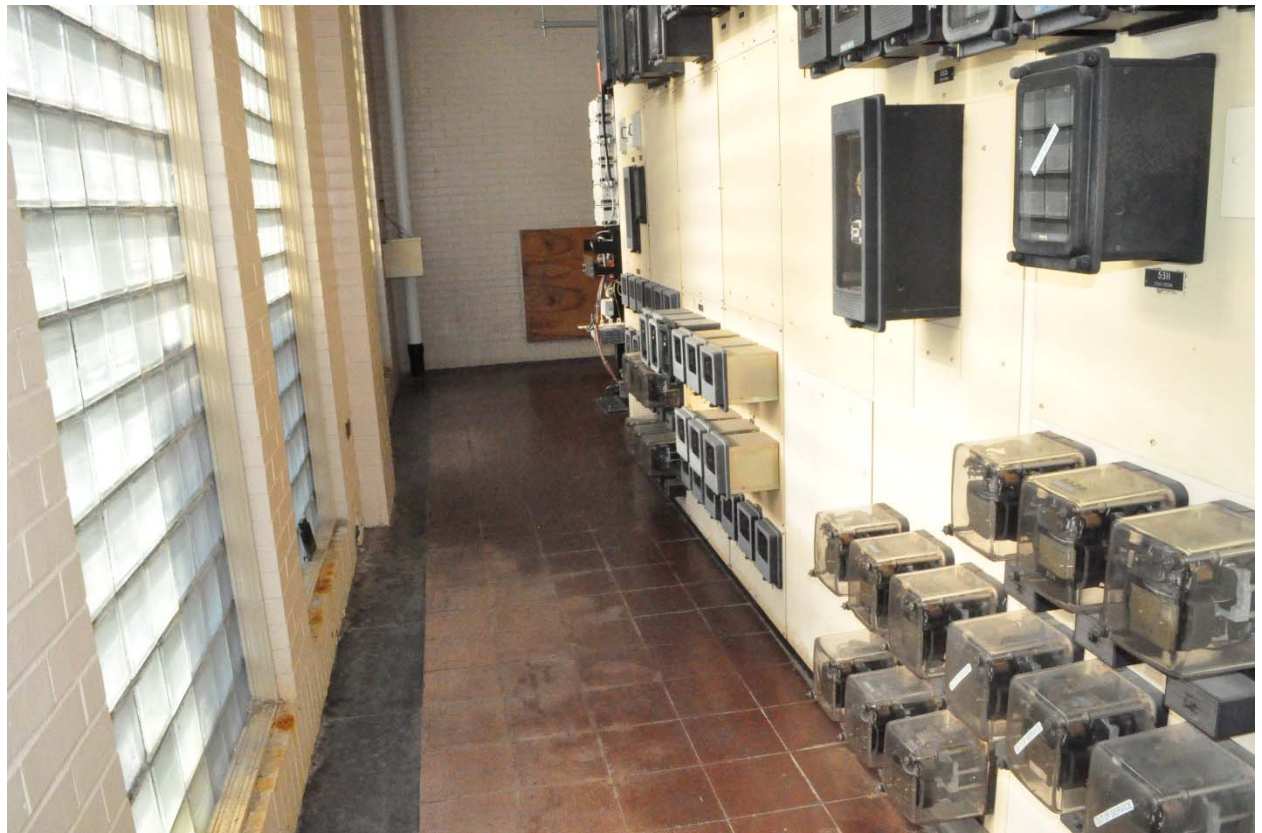
Substation #5 had some work being done during the site visit. It was noted that the single-phase transformers are all planned for replacement in 2020 – one of the transformers had visible oil staining on the foundation. There are also a few feeder breakers that are completely disconnected and sitting on the existing foundation. Those breakers that are bad could be removed and replaced since from the talks during the site visit, Substation #5 is a critical substation where it is difficult to obtain bus outages.

Figure 3-11. Substation #5 – Relay Panel Line-up

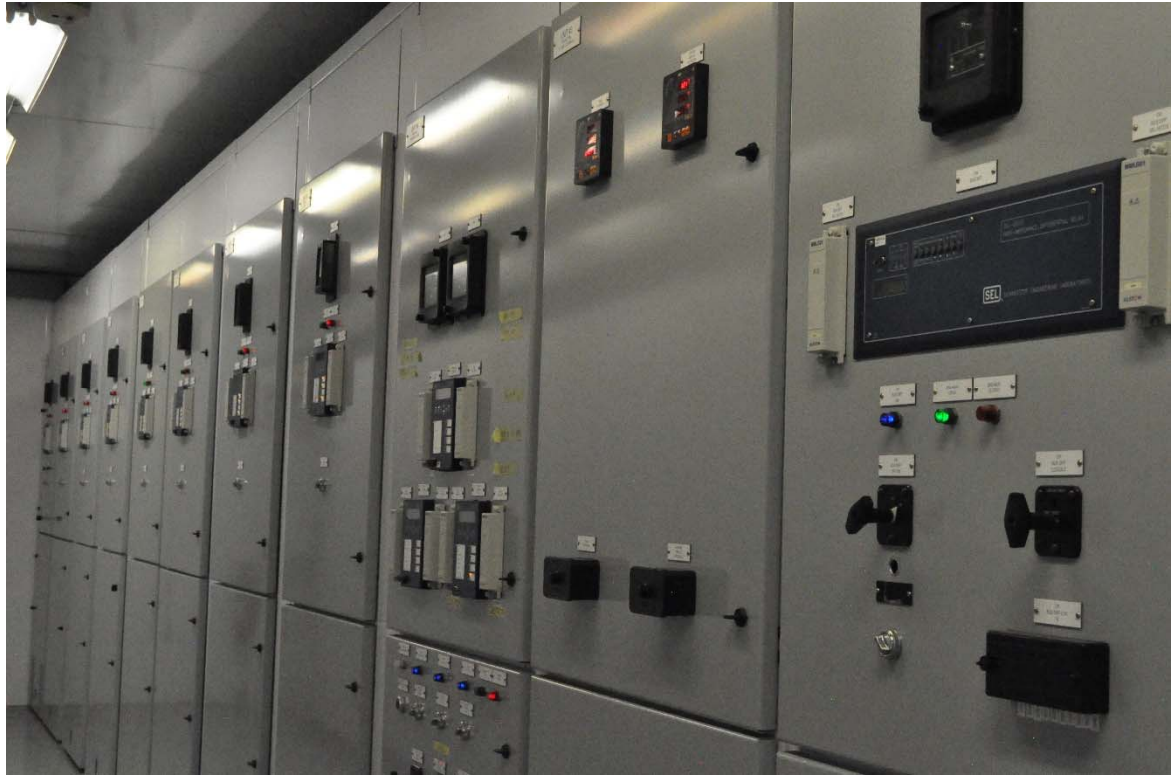
Figure 3-12. Substation #3 Switchgear Line-up

Substation #3 did have newer relaying installed but physical outdoor equipment was noted to have sections of cable tray, and even cable risers outside the control enclosure were exposed to elements where rodents could enter the cable tray and eventually nest in the control enclosure. It is advised to replace the cover for the cable trench that is broken and seal off the cable trench against rodent incursion. Substation #3 also had 115kV underground cables and it was mentioned that the expertise to replace those cables has left the company so if they fail in service, it could be an expensive fix and would likely affect customers.

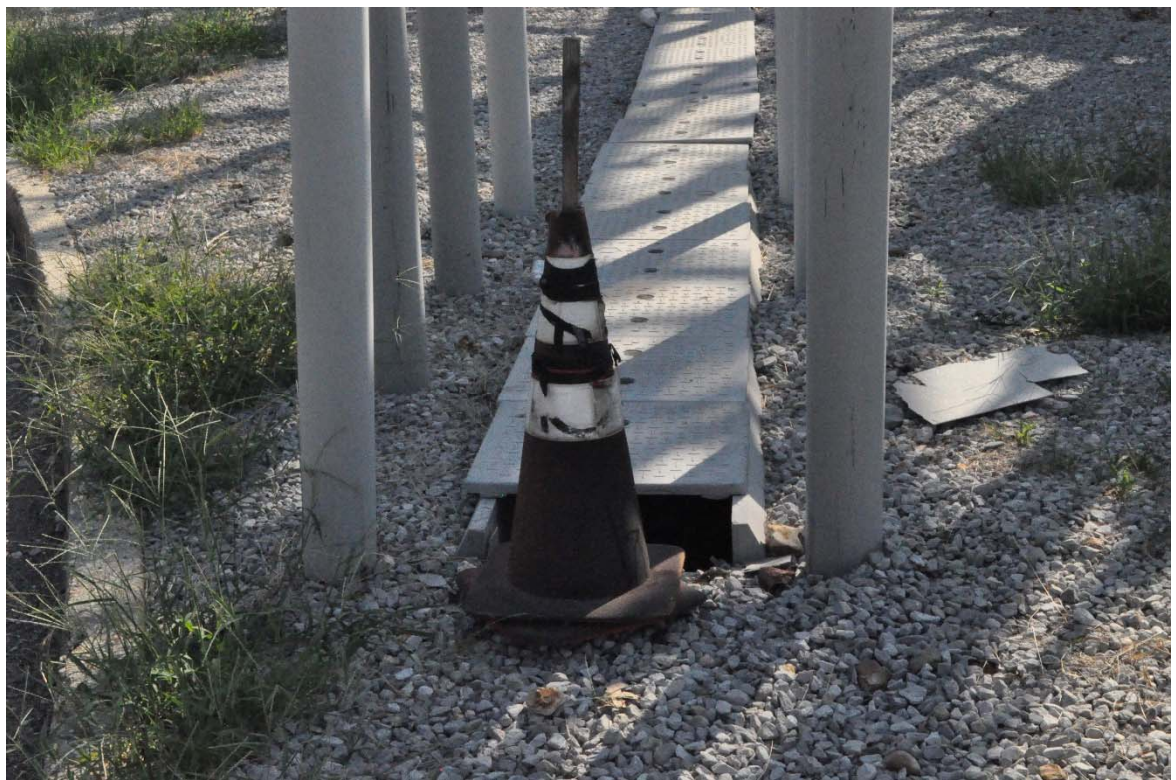
Figure 3-13. Substation #3 – cable trench issue

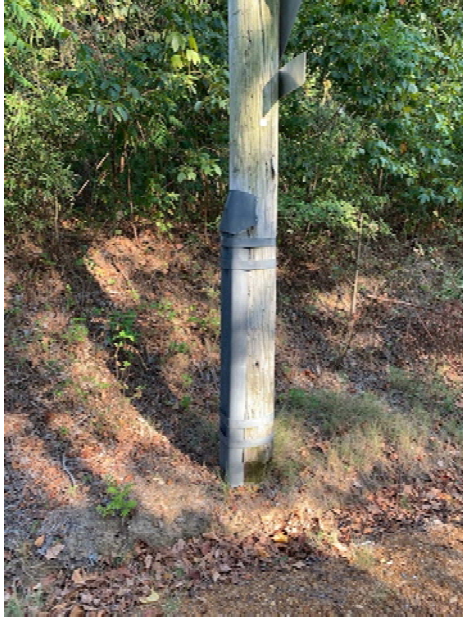
Figure 3-14. Steel truss/stub

MLGW has a pole inspection and replacement program. At the time of the HDR field visit there were approximately 3,500 poles left to replace from the inspection cycle. Approximately 800 poles were replaced during other maintenance such as car vs. pole, storms, outages, new services, etc. The reliability engineering group is producing the pole replacement list but the poles are not being scheduled and replaced. To expedite the process, steel trusses/stubs were scheduled to be installed as a faster and less expensive option for reinforcing poles with ground line rot. Stubbing does extend

the life of the pole, as long as the pole top has solid wood and cracks and checks still meet tolerances. Figure 3-14 is an example of a steel truss/stub

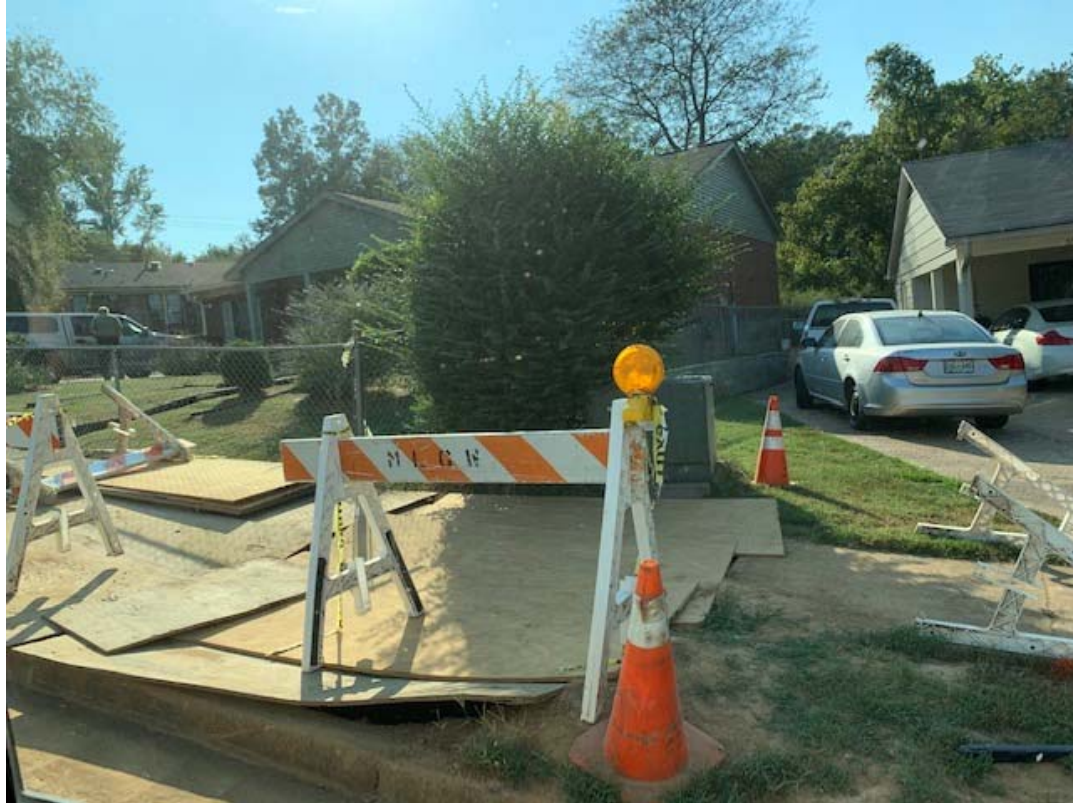
The reliability group has identified cable replacement projects that target specific areas with known problematic cable. Within these targeted areas places with faulted cable are being replaced first. The duration for an underground cable outage is normally longer than an overhead conductor outage. In addition to this, once a cable segment fails additional failures tend to happen in the same segment within a short period of time. MLGW has identified a plan for replacement; however, the plan has not been implemented or partially implemented. Figure 3-15 shows an example of unfinished cable replacement that has been in this condition for over six months. There was no active construction in the area or crews progressing the project.

Figure 3-155. Unfinished underground cable project
