Part 2

The MLGW Way...Forward

Memphis, TN
October 21, 2019

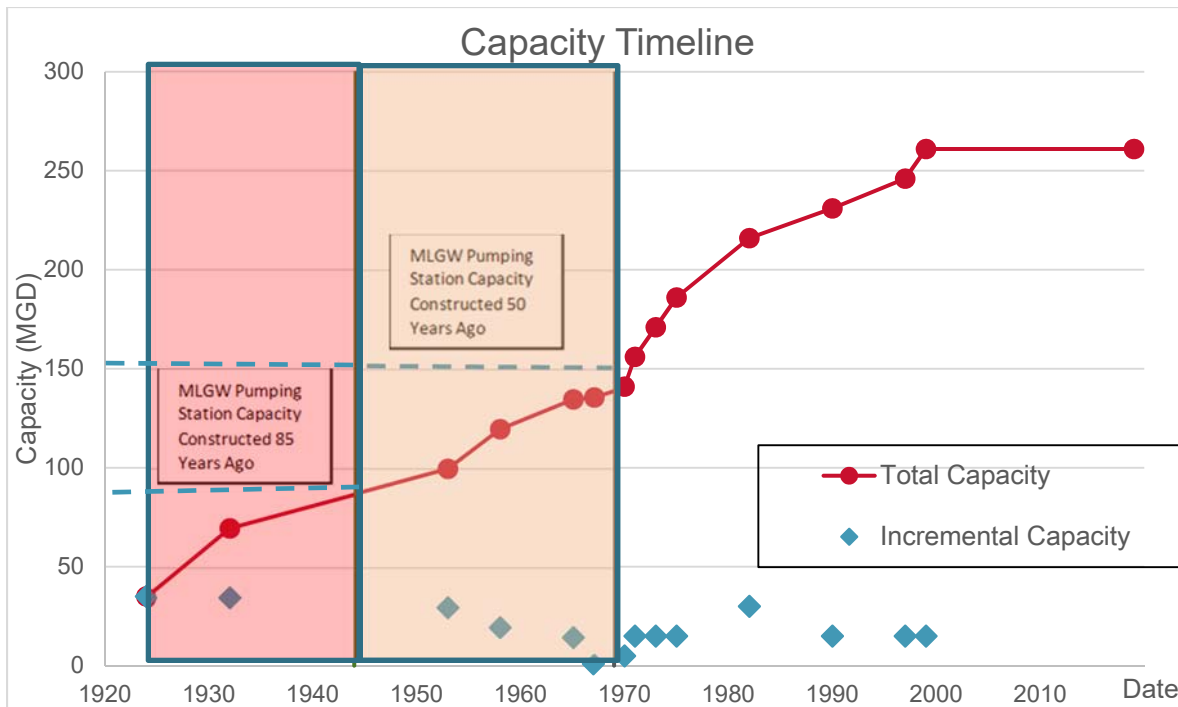
Table 4-3. Timeline of Capacity Development at MLGW

To further illustrate the age of the production infrastructure, Figure 4-3 provides a timeline of construction for pumping stations and the related capacity. Where expansions or upgrades occurred, the additional capacity is shown in the year of implementation. Milestones for 50-year and 75-year service anniversaries are included.

This figure reflects that over half of the production capacity was constructed more than 50 years ago and over 25% is over 85 years old. This is significant when you consider that all original structures and much of the original mechanical equipment is still in service.
